**Project:** GLASS WATERFALLS

**Title:** MERIT HQ

**Date:** MARCH 2011

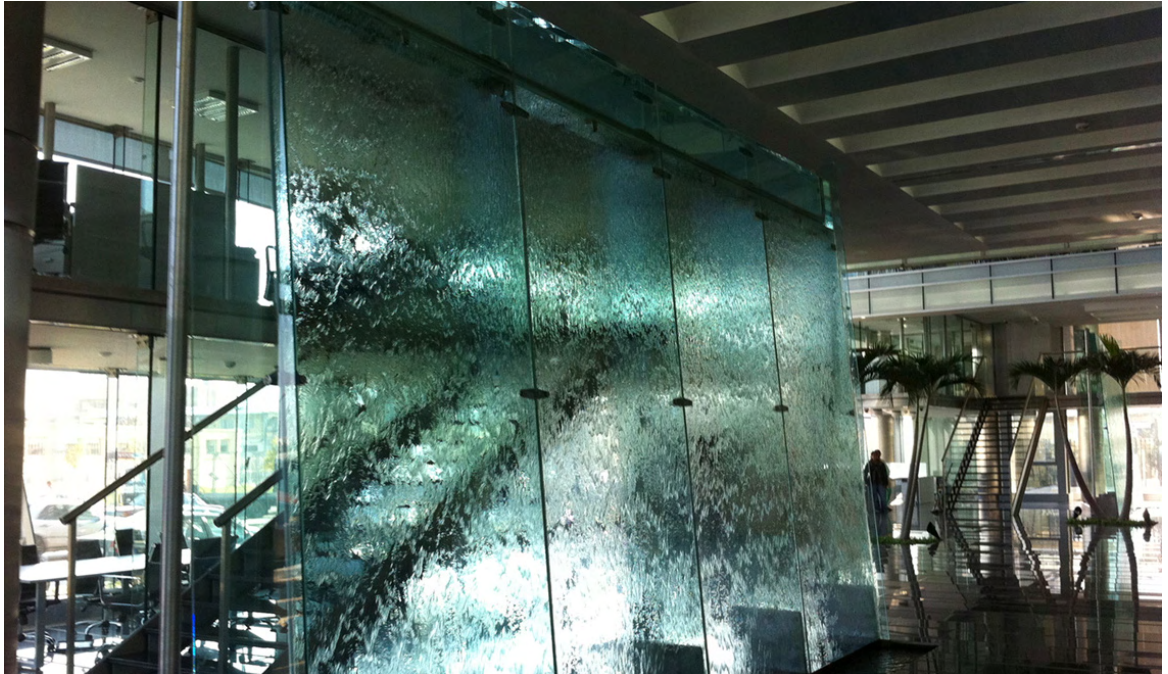
**The problem:** water running down the waterfalls is not filling all the glass surfaces at the lowest part of the glass, especially at the edges of the glass and hard to be pushed at the top part. The water is not covering the entire glass surface.

**The solution:** To solve the issue, the glass was treated using Glass Renovator, which safely and effectively removes light build-up of bonded inorganic contaminants including limescale, metal oxides and other inorganic contaminants from glass. This way all microscopic contamination was eliminated and the water is covering the entire area. ClearShield Glass Protect was also used at the top part of the glass, making the surface smoother thus the water coming down from the water container was easily pushed over the entire surface.

**The result:** The calming effect of the water sound is maximized as well as the appearance of the water fall is more eye-catching as water covers all the edges. Even after few months of the application, the result was still the pleasing.
